River Cam Restoration in South Cambridgeshire: Increasing biodiversity and improving flood control

River Cam Habitat and Access Enhancement Project - key facts

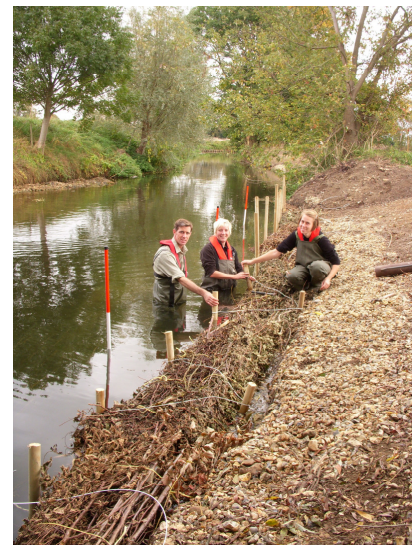
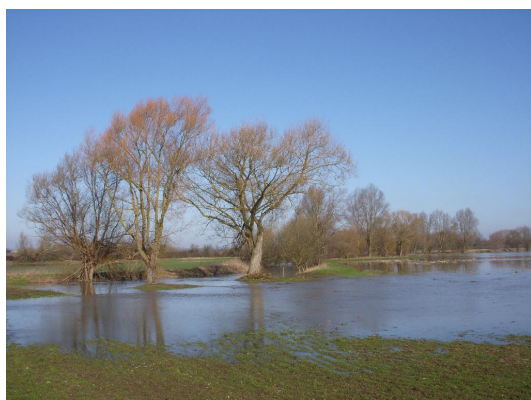
River Cam Work and Flooded Meadow;
Photos Rob Mungovan

An important element of the project was ditch restoration and the selective removal of flood levees to control flooding and high water levels along the River Cam. A 1 km ditch system was restored, reconnecting the river to a flood meadow in the river's floodplain to improve flood water flows. During recent local flood events, the results of the restoration work were tested and the constructed ditch system and restored flood meadow filled perfectly,

with adjacent land experiencing reduced flood levels. The breaches made in the levees were seemingly easing the flood pressures elsewhere in the local catchment. The project had created areas to protect fish species during river flooding and during the flood no fish were found trapped on the flood meadow.
